Home Inspection Report

Some Address, Pikeville, NC 27863

Inspection Date:

Monday April 16, 2018

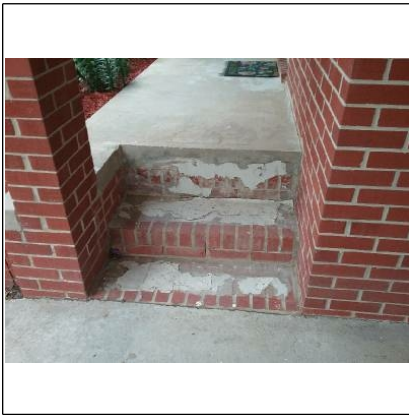
Comments Risers on step not the same height, tripping hazard.

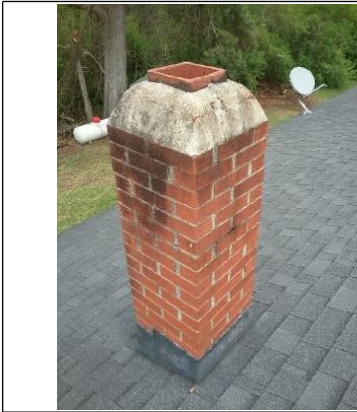
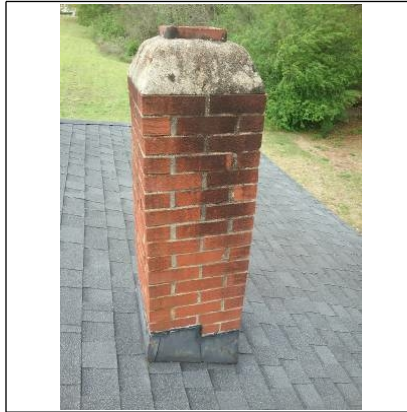
Comments Fireplace sealed off and no longer in use, recommend sealing chimney top to prevent birds and rain from entering.

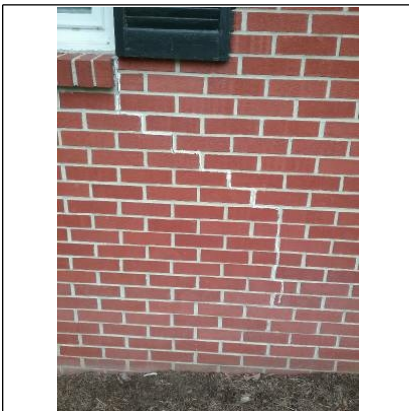
Comments Brick veneer on West side of house has typical step crack, no evidence of recent cracking noted, recommend monitoring.

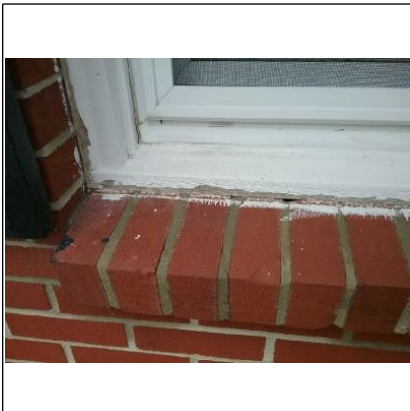
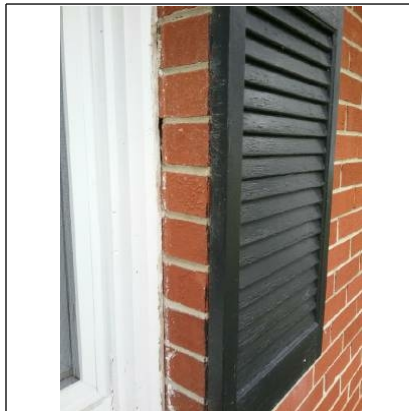
Comments Caulking around Windows deteriorated, recommend caulking and painting to prevent water entry into house.

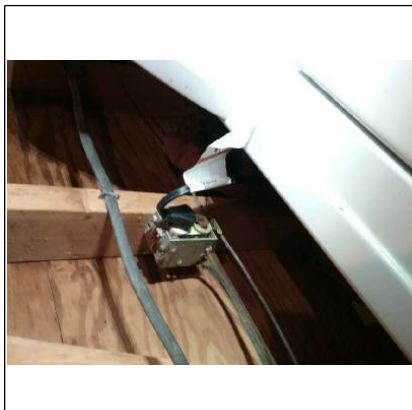
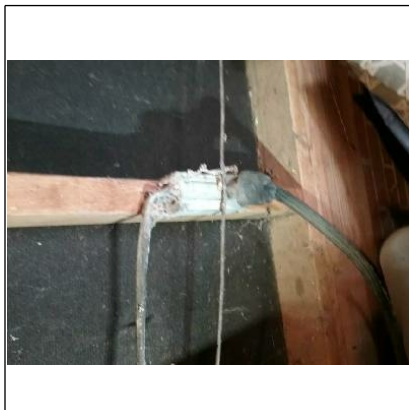
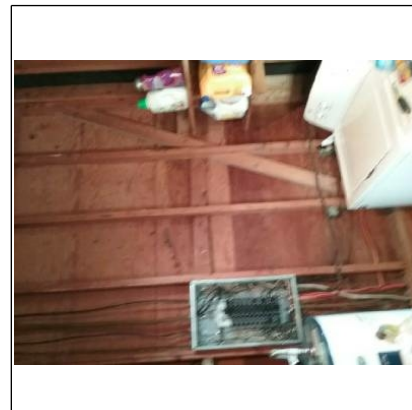
Comments Cover plates missing from electrical outlet, potential shock hazard, recommend installing cover plate
No insulation installed in laundry room wall adjoining main house, recommend insulating wall to increase efficiency.

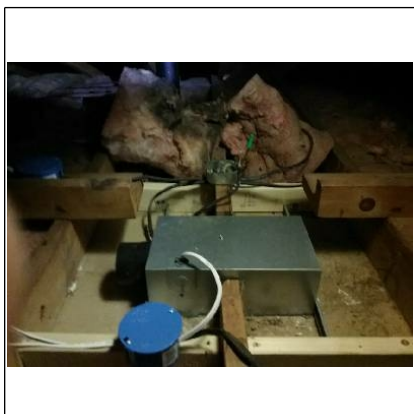
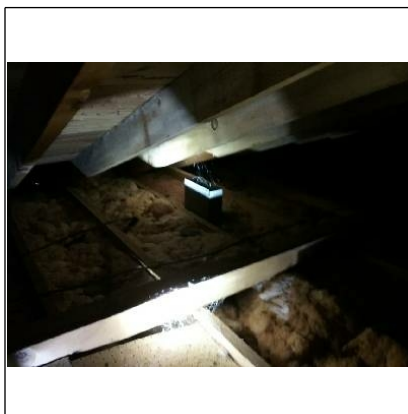
Comments Open junction boxes and exposed wires in attic, potential shock hazard, recommend securing wires and covering junction box to increase safety.
Bathroom and kitchen exhaust vent discharge into attic, recommend venting them to exterior to prevent excess moisture in attic.

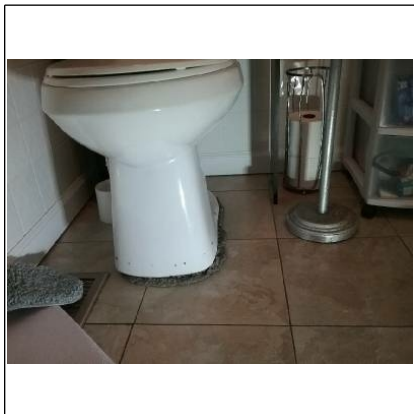
Comments Toilet in master bathroom sitting about one higher than floor on a bed of mortar, no leaks noted.

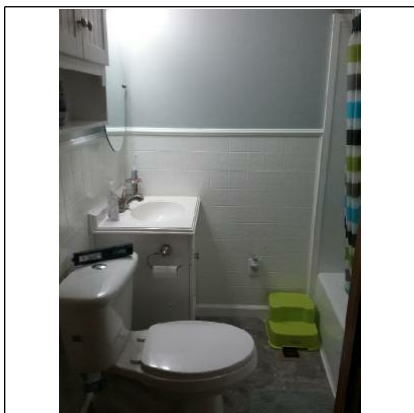
- Location** First floor bath
- Sinks** Faucet leaks: Yes No Pipes leak: Yes No
- Tubs** Faucet leaks: Yes No Pipes leak: Yes No Not Visible
- Showers** N/A
- Toilet** Bowl loose: Yes No Operable: Yes No
- Whirlpool** No
- Shower/Tub area** Fiberglass Condition: Satisfactory Marginal Poor Rotted floors
Caulk/Grouting needed: Yes No
- Drainage** Marginal
- Water flow** Satisfactory
- Moisture stains present** No
- Doors** Satisfactory
- Window** None
- Receptacles present** Yes Operable: Yes No
- GFCI** No Recommend GFCI
- Open ground/Reverse polarity** No
- Heat source present** Yes
- Exhaust fan** Yes
- Comments** Bathroom sink slow to drain, possible blockage, recommend evaluation by plumber to determine problem.
- Photos**

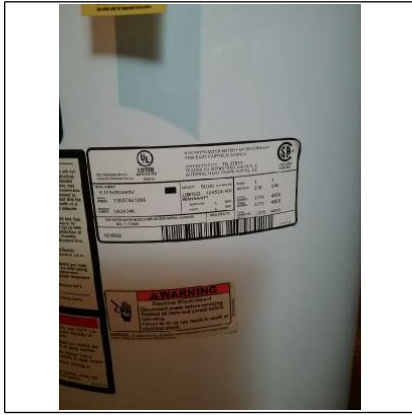
Comments Relief valve extension pipe missing, potential safety hazard, recommend installing extension pipe.

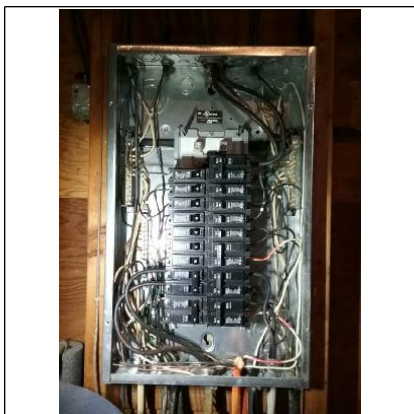
Comments Branch wire for water heater under sized, wire could overheat before circuit breaker trips, Recommend licensed electrician repair and/or replace as necessary.

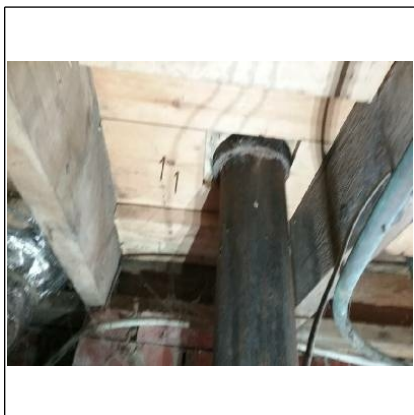
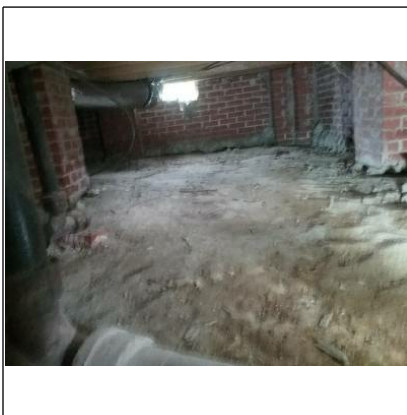
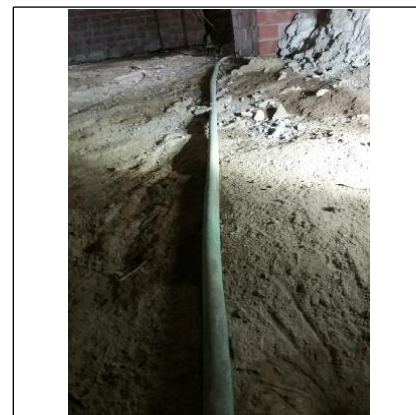
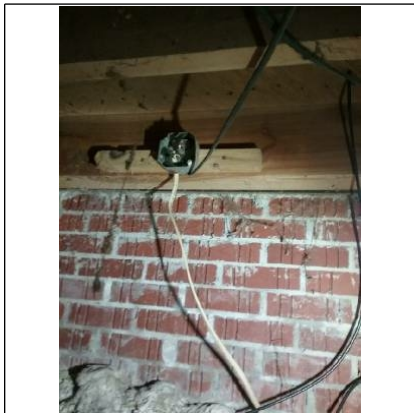
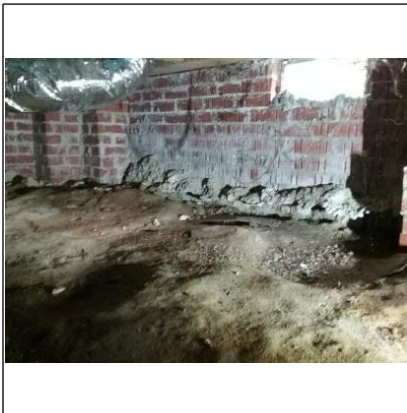
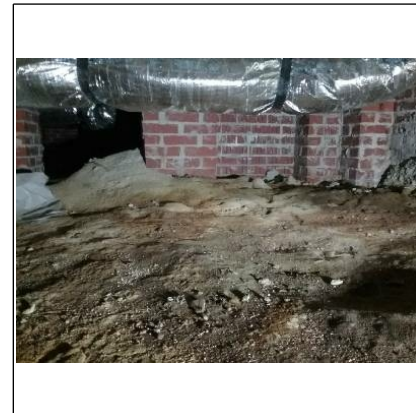
Comments No insulation in crawlspace, recommend installing insulation to increase efficiency.

Comments No vapor barrier installed in crawlspace, recommend installing to reduce moisture level.
