Home Inspection Report

Some Address, Pikeville, NC 27863

Inspection Date:

Monday April 16, 2018

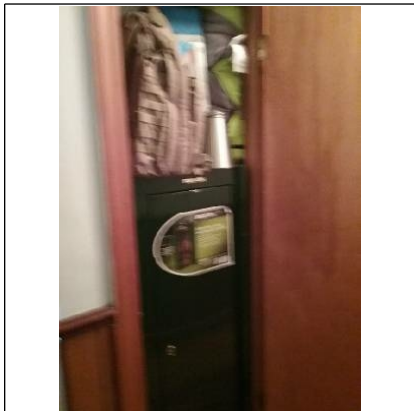
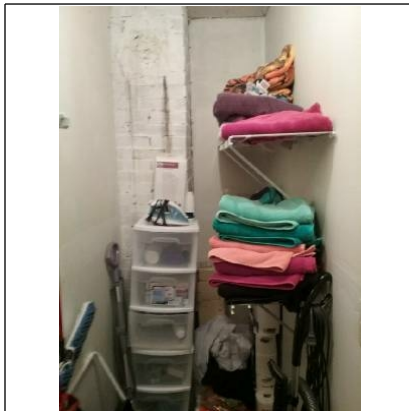
Comments Cover plates missing from electrical outlet, potential shock hazard, recommend installing cover plate
No insulation installed in laundry room wall adjoining main house, recommend insulating wall to increase efficiency.
